HABITAT MANAGEMENT PLAN CUMMINS WHITEWATER SITE DEVELOPMENT

Panattoni Development
900 SW 16th Street, Suite 300
Renton, Washington 98057

Anchor QEA, LLC
720 Olive Way, Suite 1900
Seattle, Washington 98101

March 2016

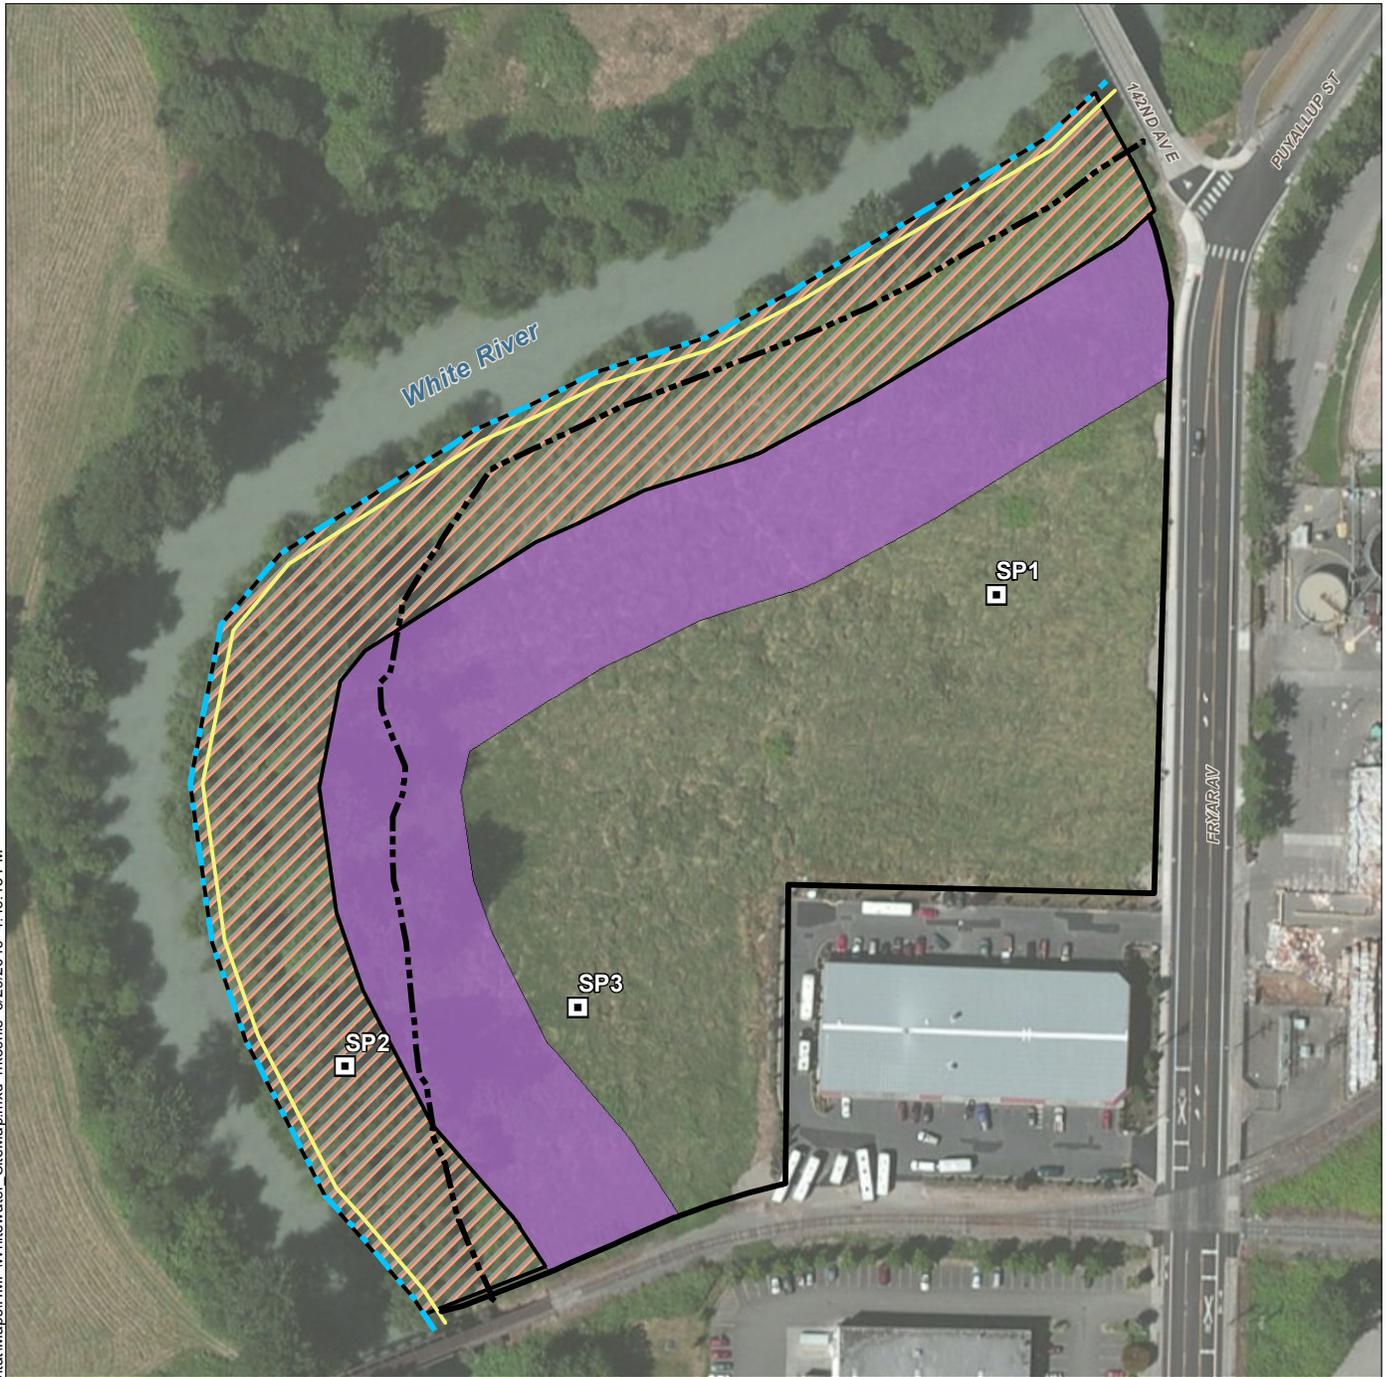
- Project Area
- Approximate Ordinary High Water Mark
- - - 100-year Flood Elevation (49 ft NGVD29)
- Approx Floodway Boundary
- ▨ Riparian Management Zone
- Shoreline Zone
- Wetland Data Plot Location

The White River meets the criteria of a Type S stream, "shorelines of the state," under chapter 90.58 Revised Code of Washington. Its shoreline designation in the SMP is Urban Conservancy, with a 100-foot Riparian Management Zone standard. Shorelands designated in the project area extend to the floodway for the White River, which extends to the 49-foot contour line in this area. The floodway and the associated 200-foot shoreline zone are shown on Figure 2.

During the site investigation on November 16, 2015, Anchor QEA biologists visited the site to perform an OHWM survey of the project area. However, the White River water elevation was elevated and had submerged much of the vegetation along the shoreline area (including many large trees), preventing delineation and survey of the OHWM. This vegetation remained submerged through December 2015. For the purposes of this HMP, an approximate OHWM boundary was used to establish shoreline buffer boundaries and develop conceptual development plans. The approximate OHWM was based on professionally surveyed water surface elevations collected on November 21 by Barghausen Consulting Engineers, and was then adjusted 10 feet towards the river to approximate the edge of visible but submerged vegetation. This approximate OHWM location is shown on Figure 2 and aligns with the trees observed to be submerged during the November survey, as shown overlaid on the aerial photo.

During the site visit on November 16, 2015, Anchor QEA biologists assessed three data plots for wetland characteristics on site (Figure 2). No evidence of standing water or wetland soils were observed. Wetland data sheets are included as Appendix A of this report. National Wetlands Inventory maps do not show any wetlands in the vicinity of the project area (USFWS 2015). Along the western boundary of the site, a ditch separates the upland field area from the forested riparian area. During the site visit in November 2015, the ditch contained approximately 2 feet of standing water, but no wetland soils were present (Sample SP2 in Appendix A and Figure 2). This ditch is dominated by red alder

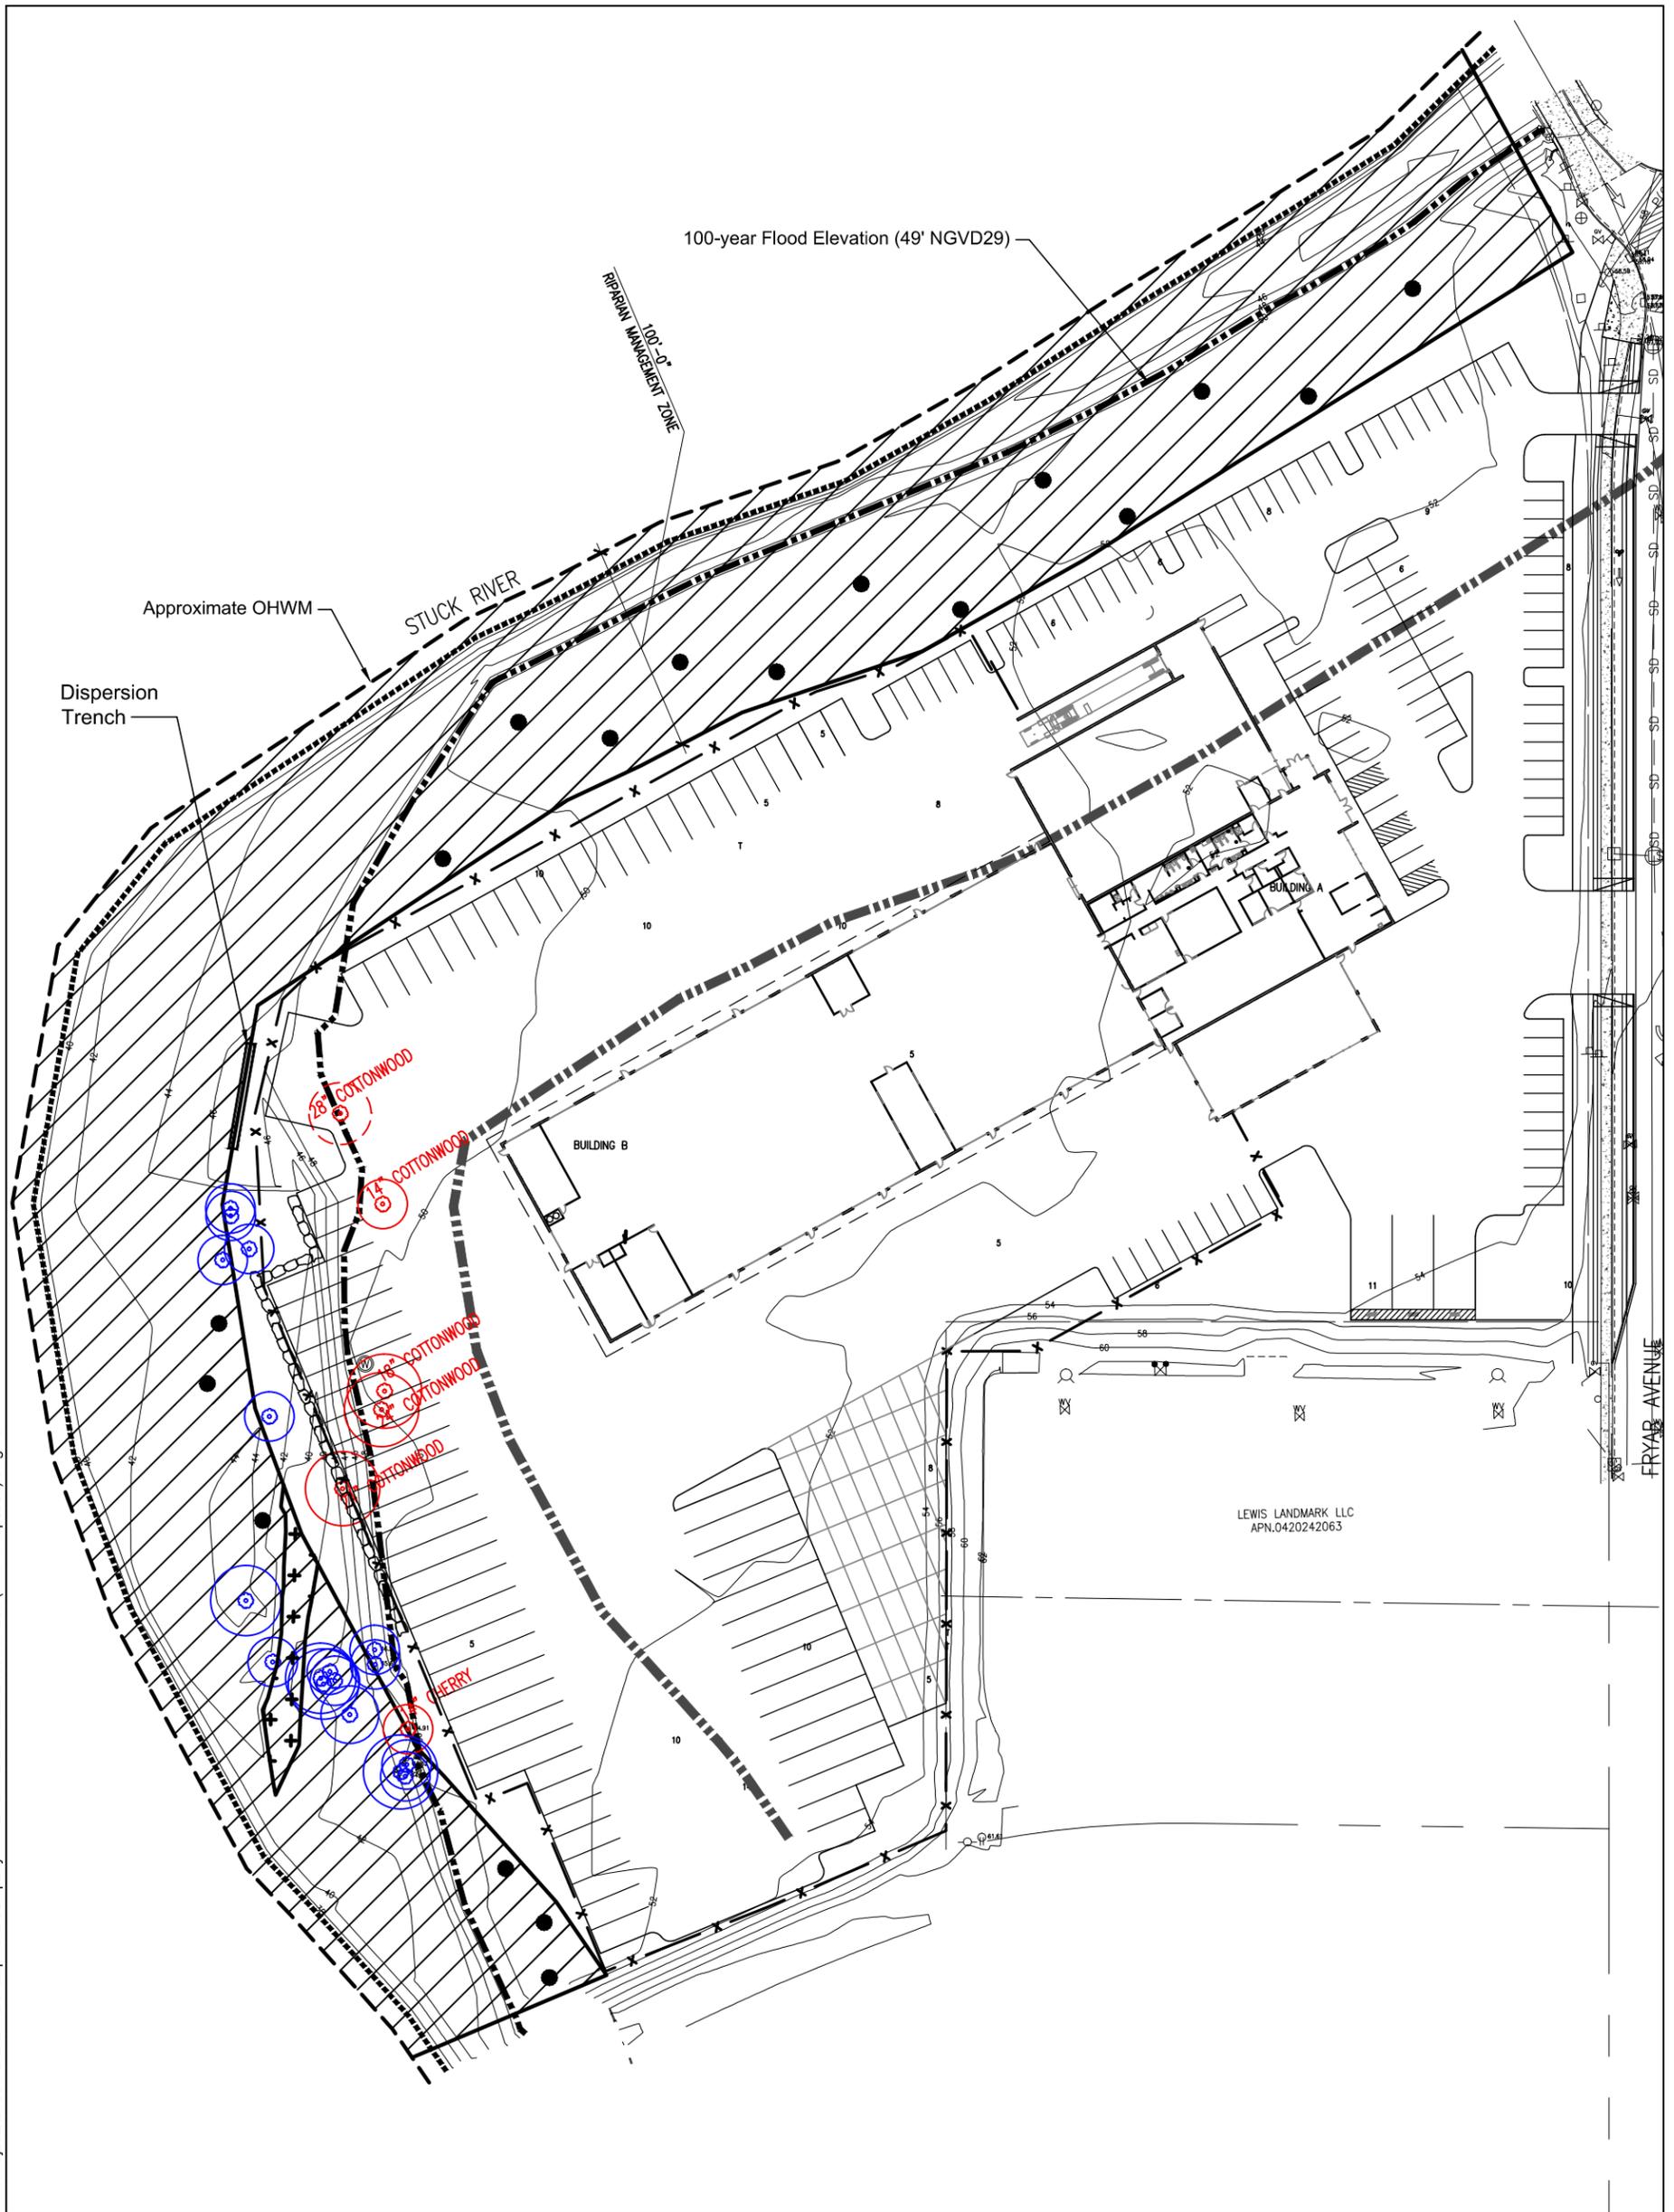
Figure 3
 Proposed Development Plan
 Whitewater Habitat Management Plan
 Panattoni Development Company

- LEGEND:**
- Existing Contours
 - 100-year Flood Elevation (49 ft NGVD29)
 - Approximate Location of Floodway Boundary
 - 200' Shorelands Offset
 - OHWM

- Riparian Management Zone to be Enhanced
- Significant Trees to be Removed
- Significant Tree to be Retained
- Native Trees to be Installed
- Proposed Livestake Willows

The construction associated with the development project, including all excavation and grading activities, will occur outside of the 100-foot Riparian Management Zone (Figure 3). Some noise will result from traffic throughout the construction site; however, construction will only be conducted during the day and is not likely to increase the background noise levels associated with the adjacent industrial land use.

The northern and western parking areas, as well as a portion of the northern building is proposed to be within the 200-foot shoreline zone. Five cottonwood trees, between 14-inch diameter at breast height (DBH) and 28-inch DBH, will be removed from within the 200-foot shoreline zone as part of the proposed development (all outside the 100-foot Riparian Management Zone). One 14-inch DBH cherry tree has a drip line that extends into the grading area, and is therefore counted as a tree requiring mitigation in this HMP (however, the tree may not be impacted during construction). No other trees will be impacted or have drip lines that extend into the grading or construction areas as part of the project. The loss of five cottonwood trees and the potential impact from grading within the dripline of the one cherry tree will be mitigated with replacement of trees at a 3:1 ratio. Eighteen native trees will be planted within the Riparian Management Zone to fulfill this mitigation requirement (Figure 3). Additional activities to off-set construction activities in the shoreline zone will include removal of invasive shrubs and installation of live-stake willows in specific areas of the Riparian Management Zone.

The plantings are proposed at a ratio of 3:1 (mitigation:impact). To meet this requirement, the project proposes to plant 18 native trees within the 100-foot Riparian Management Zone (Table 2). Additionally, an approximately 1,750 square foot area will be planted with livestake willows (Figure 3). This area is in a ditch along the shoreline with wetter conditions than the surrounding areas. This area contains existing native vegetation, including cottonwood, snowberry, and red alder, that will not be removed; the installed willows will be added to low lying areas without trees and shrubs after the removal of invasive species. Of this 1,750 square feet of space, an estimated 700 square feet will be available for livestake willow installation.
