# Wetland Delineation and Critical Areas Report

Greenwater Battery Energy Storage System

City of Sumner and Pierce County, Washington

January 2024

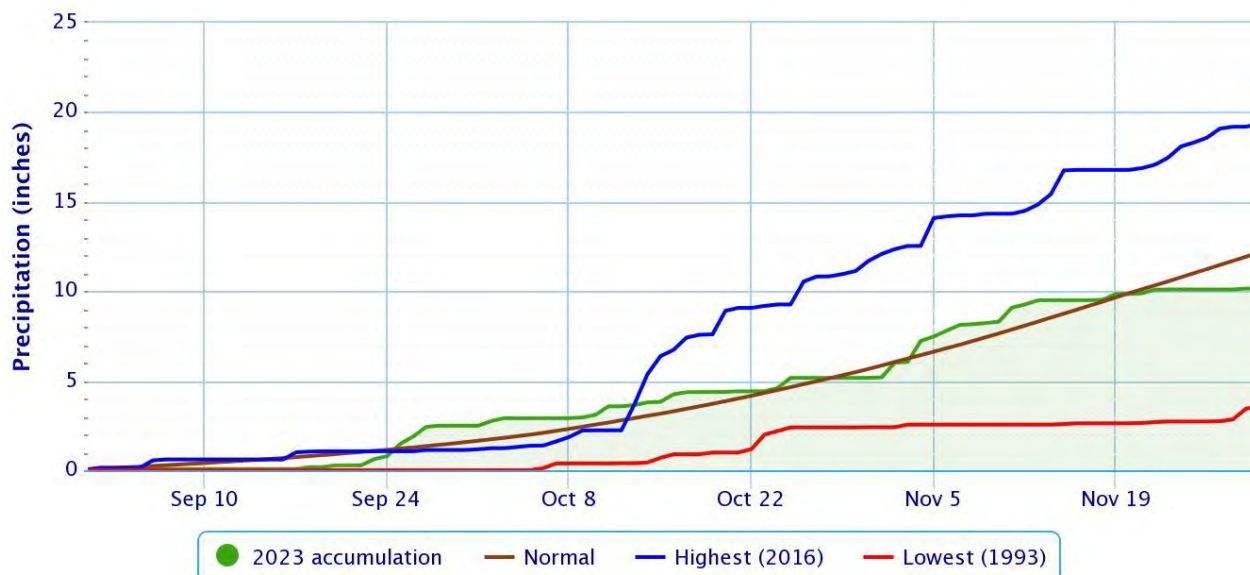
**Accumulated Precipitation – Tacoma, WA (September 1 to November 30, 2023)**

Source: NOAA Regional Climate Center, Applied Climate Information System

Based on the climate analysis, the water table and saturation depths documented during the delineation were likely consistent with long-term variability at the site, though slightly drier than average. Inundation and saturation were observed at Wetland A during the wetland delineation on November 30.

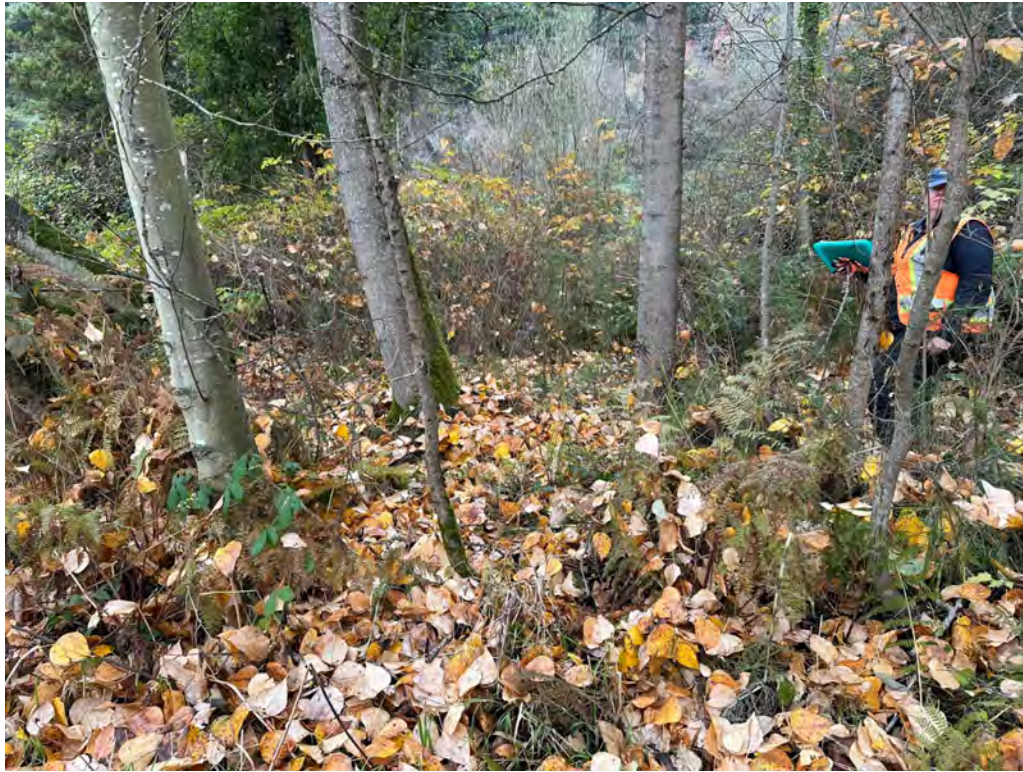
Photo 1: Wetland A

Observed soils had a mucky loam surface about 7 inches deep which met the Loamy Mucky Mineral (F1) hydric soil indicator.

The vegetation community consists of red alder, black cottonwood, salmonberry, red-osier dogwood (*Cornus alba*), Himalayan blackberry, giant horsetail (*Equisetum telmateia*), youth-on-age (*Tolmiea menziesii*), lady fern (*Athyrium cyclosorum*), stinging nettle (*Urtica dioica*), and reed canarygrass (*Phalaris arundinacea*).

Wetland A rates as **Category III** (17 out of 27 points). It rates low (5 out of 9 points) for improving **water quality**. Site potential is low since the site lacks dense herbaceous cover to trap sediments. Landscape potential is low since there are no known sources of pollutants. Societal value is high since the wetland discharges within 1 mile to a stream with impaired waters, and the basin has a total maximum daily load (TMDL)/water quality improvement project. Wetland A rates low (5 out of 9 points) for **hydrologic functions**. Site potential is low since the site lacks dense rigid plants to reduce surface flow velocity. Landscape potential is low since the wetland does not receive excess surface runoff. Societal value is high as flooding may occur in the sub-basin immediately down-gradient of the wetland. Wetland A rates moderate (7 out of 9 points) for **habitat functions**. Site potential is moderate due to moderate habitat and species diversity. Landscape potential is high based on the percent of undisturbed habitat near the wetland. Societal value is moderate based on the presence of priority habitats nearby.

In the City of Sumner, Category III wetlands with a habitat function score of 7 points require a **150-foot buffer** [Sumner Municipal Code (SMC) 16.46.150]. This can be reduced to 110 feet if measures are used to minimize impacts to the wetland, as summarized in Table 2 of SMC 16.46.150. The SMC also allows for reduced buffer widths where the standard buffer width is crossed by a legally established road or other linear facility or barrier, thus isolating a portion of the buffer. The west side of Wetland A abuts the road prism of East Valley Highway East and lacks a functional buffer. Part of the north buffer is constrained by a house and driveway. The functional part of the buffer is forested with Douglas-fir, vine maple, beaked hazelnut, low Oregon grape, and sword fern. The functional wetland buffer is shown on **Figures 5a and 5b**.

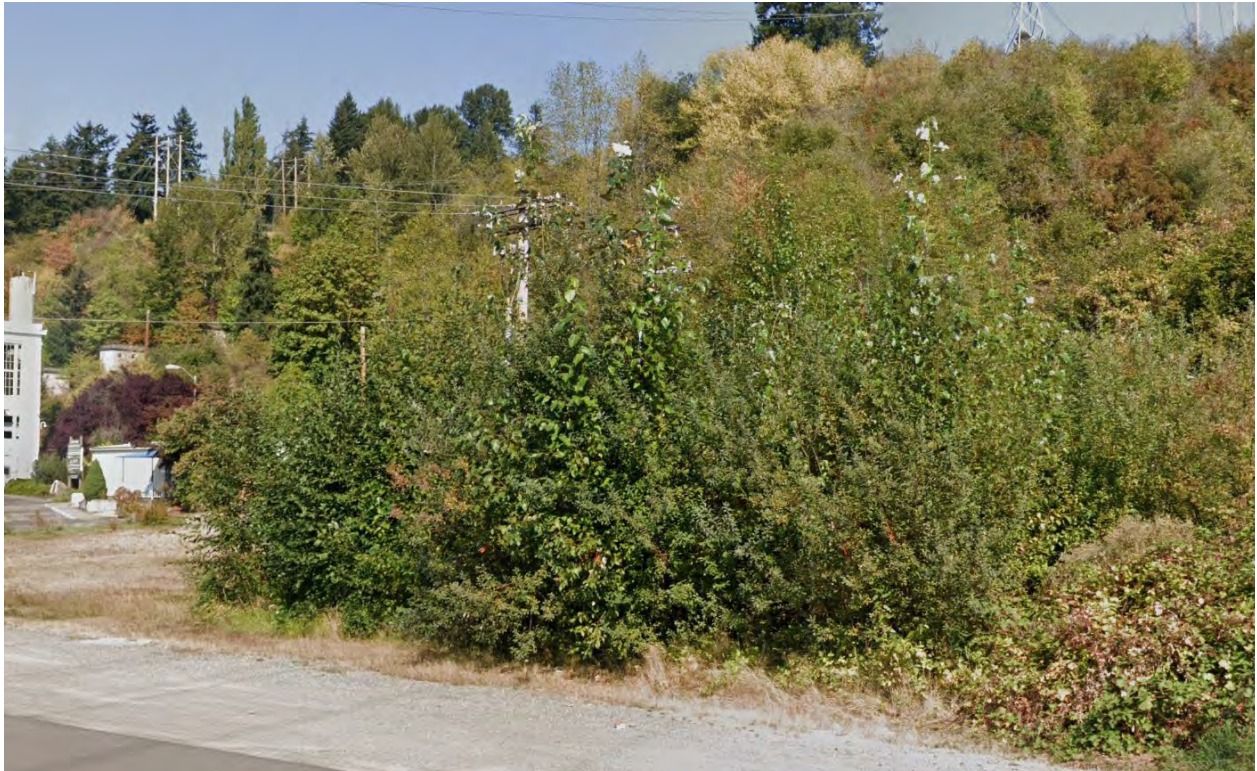
Photo 2: Wetland B from East Valley Highway

Wetland B rates as **Category III** (Terracon 2022a). It rates low for improving **water quality**. It rates low for **hydrologic functions**. It rates moderate for **habitat functions**. Refer to the Terracon report for rating forms and figures.

In the City of Sumner, Category III wetlands with a moderate habitat function require a **150-foot buffer** (SMC 16.46.150). This can be reduced to 110 feet if measures are used to minimize impacts to the wetland, as summarized in Table 2 of SMC 16.46.150. The SMC also allows for reduced buffer widths where the standard buffer width is crossed by a legally established road or other linear facility or barrier, thus isolating a portion of the buffer. The west side of Wetland B abuts the road prism of East Valley Highway East and lacks a functional buffer. The functional part of the buffer contains managed woody vegetation under powerlines. The functional wetland buffer is shown on **Figures 5a and 5b**.

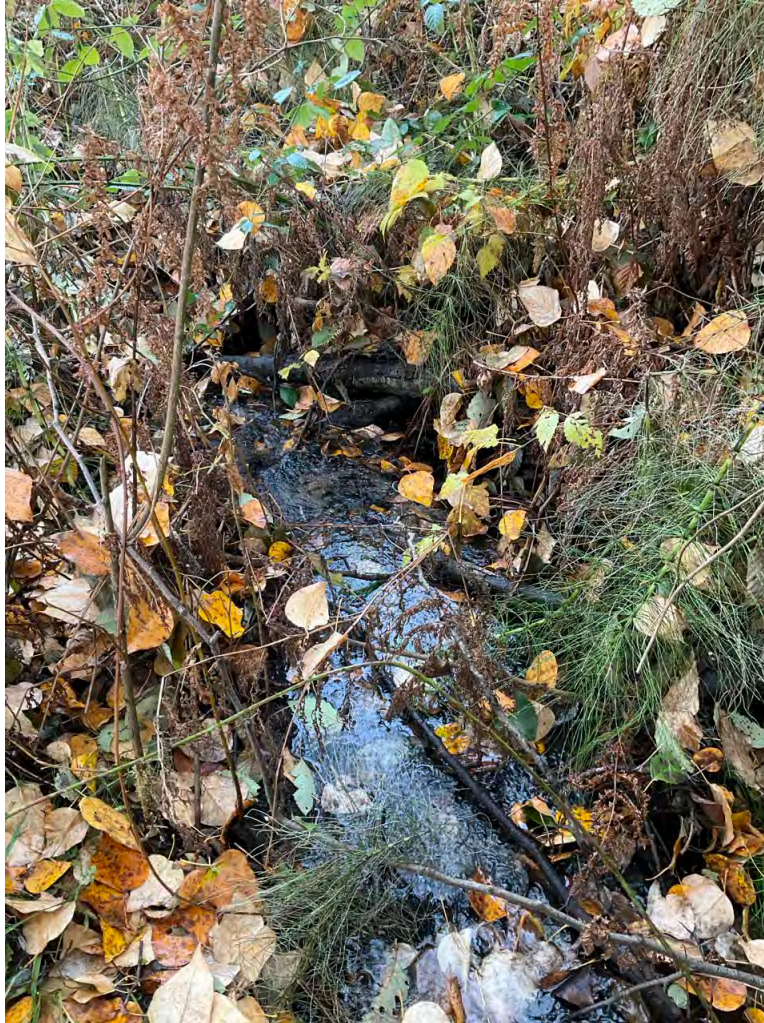
Photo 3: Unnamed Intermittent Stream

Stream A is approximately 4 to 6 feet wide and 6 inches deep at the OHWM. The stream was flowing at the time of inspection (**Photo 3**). The channel narrows and becomes less discernable upstream of Wetland A. Downstream of Wetland A, the stream flows through dense Himalayan blackberry.

Stream A is not mapped by the NHD, the NWI, or other inventories. The offsite stream is mapped by the NHD and WDNR (2023a). It begins in a ravine north of the study area and is mapped as a Type Ns (non-fish, seasonal) stream per the WDNR water typing classification system (WAC 222-16-030). Stream A would also be classified as Type Ns stream. The SMC 16.56.100 specifies that Type Ns waters require a 25-foot-wide buffer. This buffer is exceeded by the 150-foot buffer required for Wetland A.

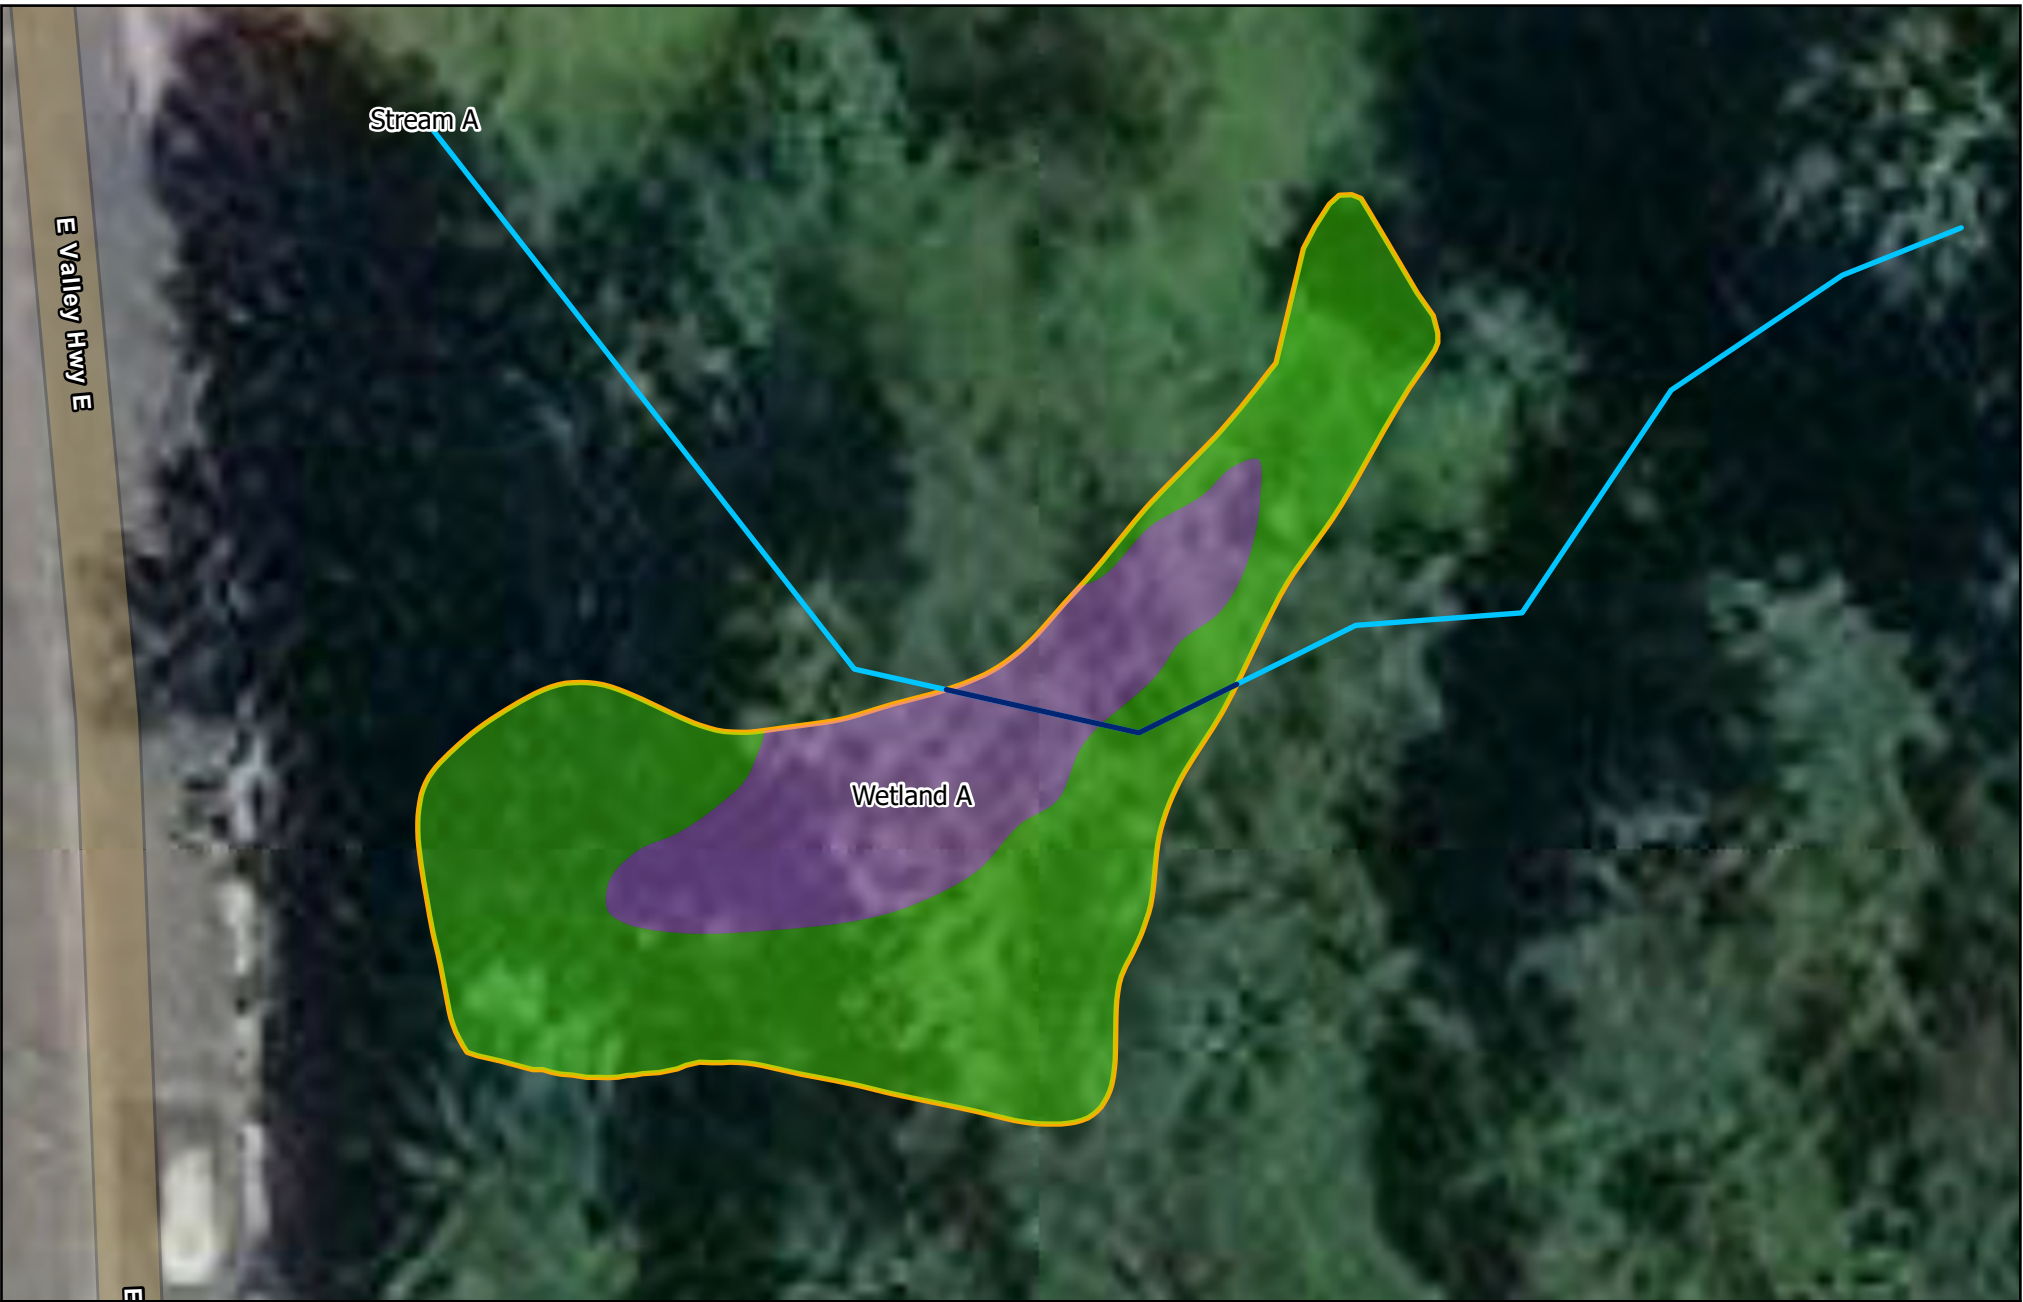
GREENWATER BESS  
 BRIGHTNIGHT  
 CITY OF SUMNER AND PIERCE COUNTY, WASHINGTON  
**HYDROPERIODS**

- Wetland Boundary (0.11 Acres)
- Delineated Stream
- Hydroperiod**
- Saturated (0.08 Acres)
- Occasionally Flooded (0.03 Acres)
- Intermittent/Seasonally Flowing Stream (36 Feet)
