# Phase I Environmental Site Assessment

## Greenwater Storage

2005 Cottage Road East, 1705, 1808, 1820 to 1904, 2008, and 2111 East Valley Highway East, and 2120 Lakeland Hills Way

January 23, 2024 | Terracon Project No. 81237631

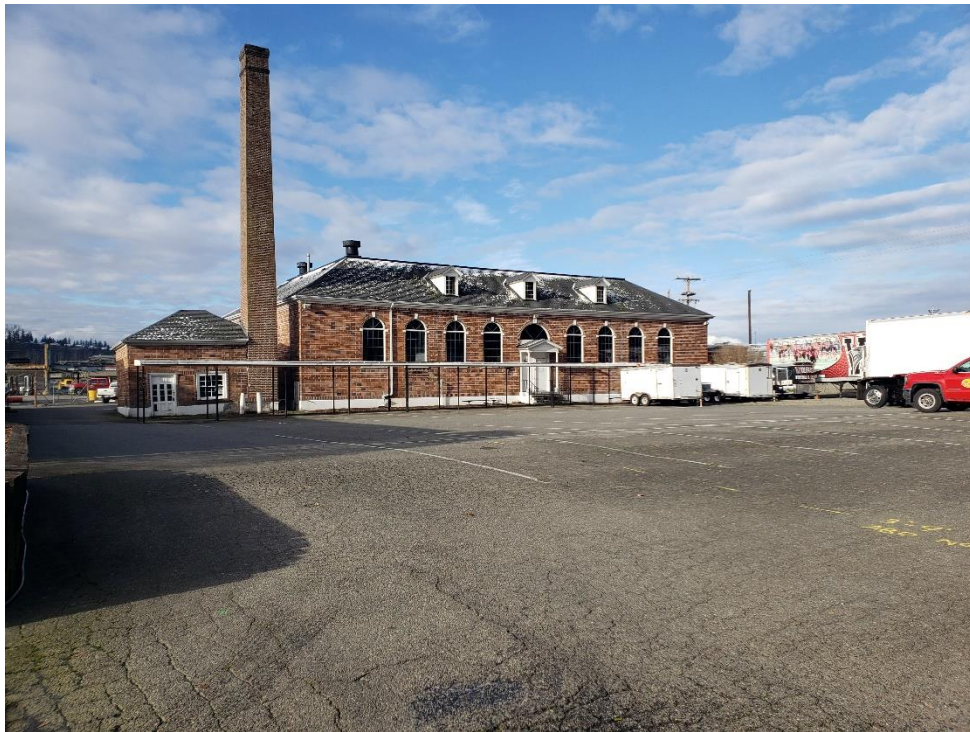
**Photo 2** Typical view of the northern portion of Parcel A with the vacant gym building and attached former coal furnace and stack to the left, facing west-northwest from the east-central portion of Parcel A.

The on-site vacant gym building had natural gas-powered suspended heaters which were observed in the northern portion of the building. The heaters appeared to be in good condition; however, according to Ms. Robyn Honeysett, Parcel A owner, natural gas was shut off to the building in August 2023. The gym was historically heated by a coal burner which adjoins the gym building.

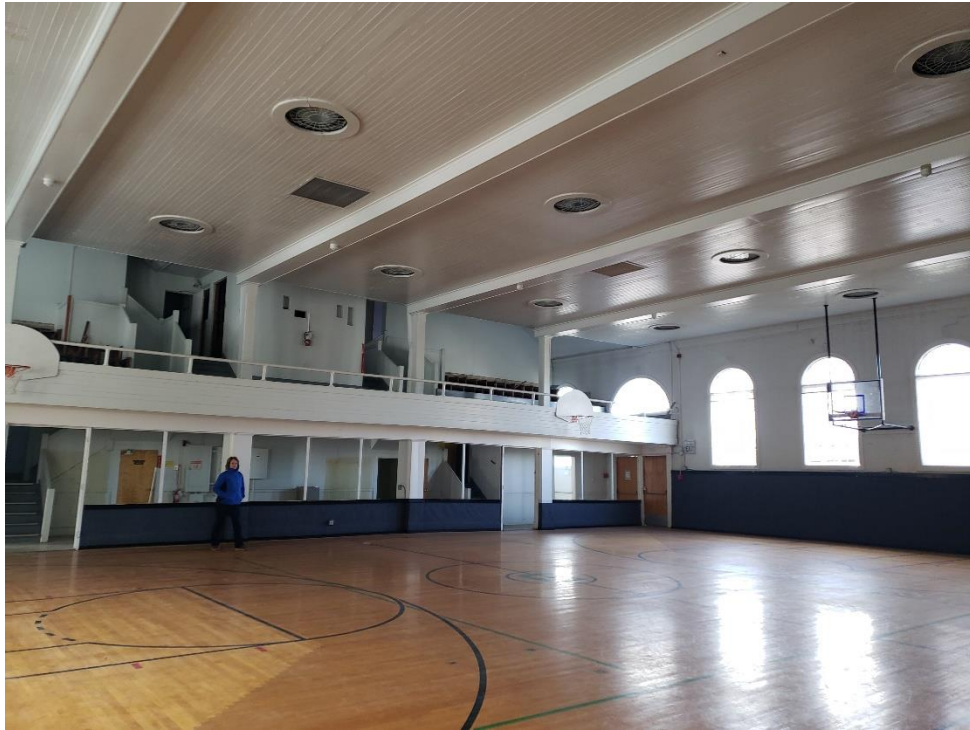
**Photo 3** Typical interior view of the vacant gym building on Parcel A.

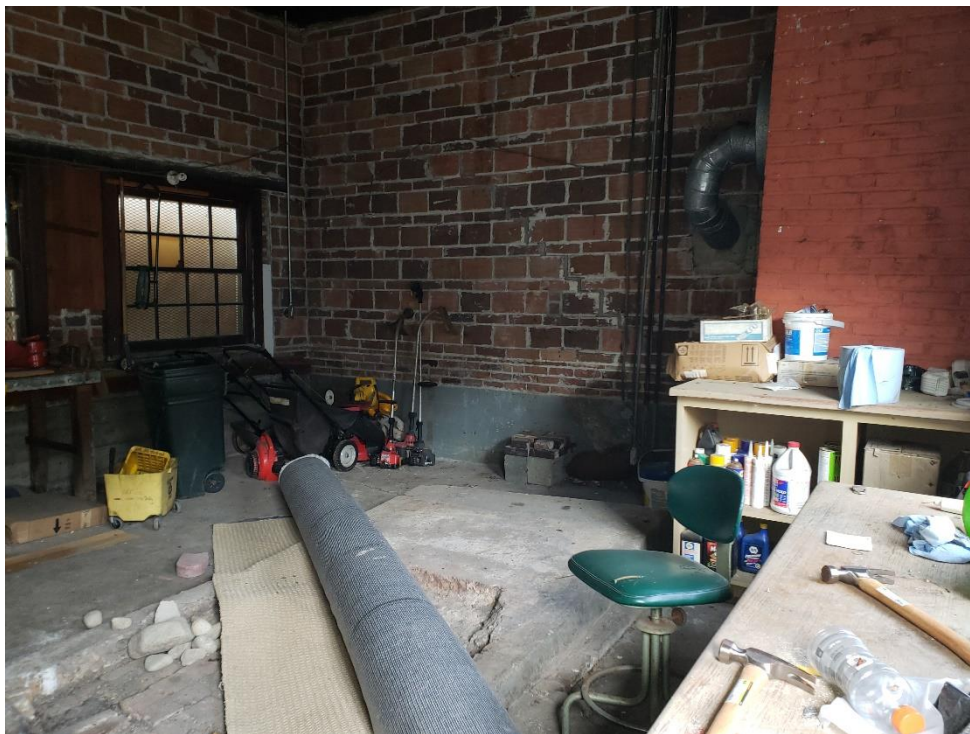
**Photo 4** Typical interior view of the former coal furnace, attached to the south of the vacant gym.

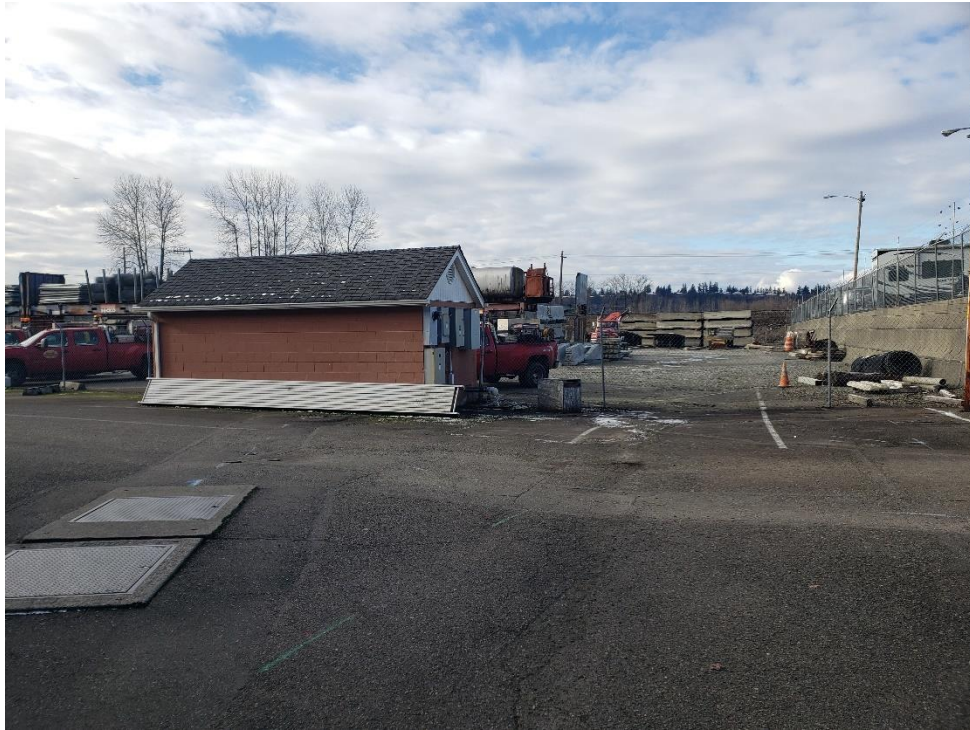
**Photo 5** Typical view of the City of Sumner well pump house on Parcel A facing west.

The domestic water well located on Parcel A to the west of the vacant gym is within a pumphouse that was gifted to the City of Sumner in the early 2000s, who now owns the pump house and has an access easement from East Valley Highway East to the pump house. The pump house was inaccessible at the time of the site reconnaissance. Staining or evidence of a release were not observed in the vicinity of the pump house.

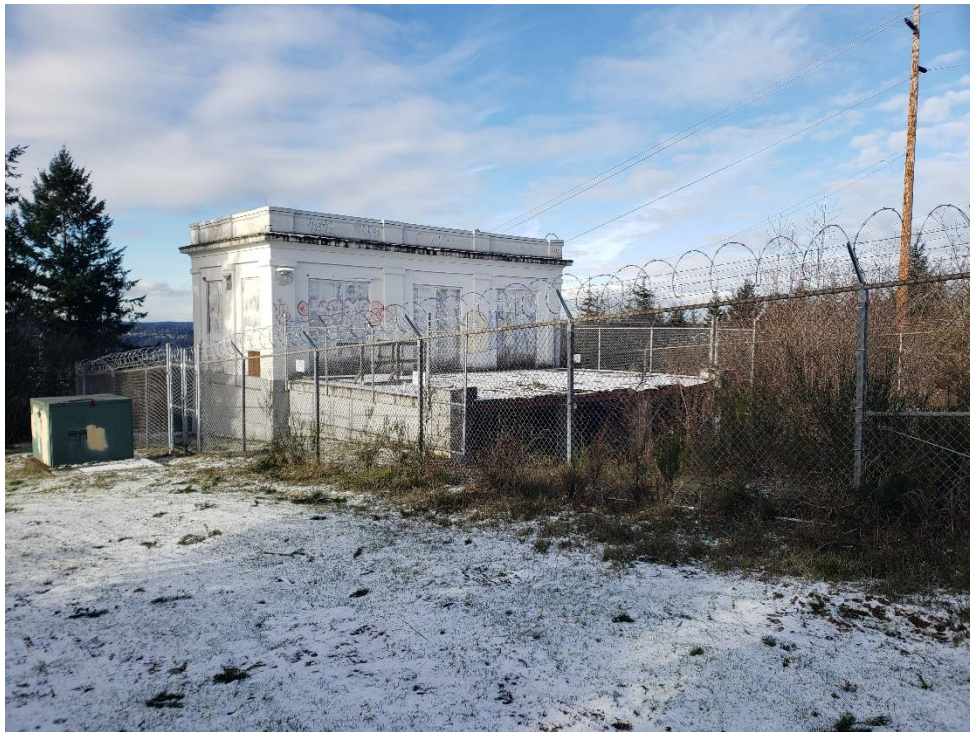
**Photo 12** Typical view of a Cascade Water Alliance equipment building on Parcel B.

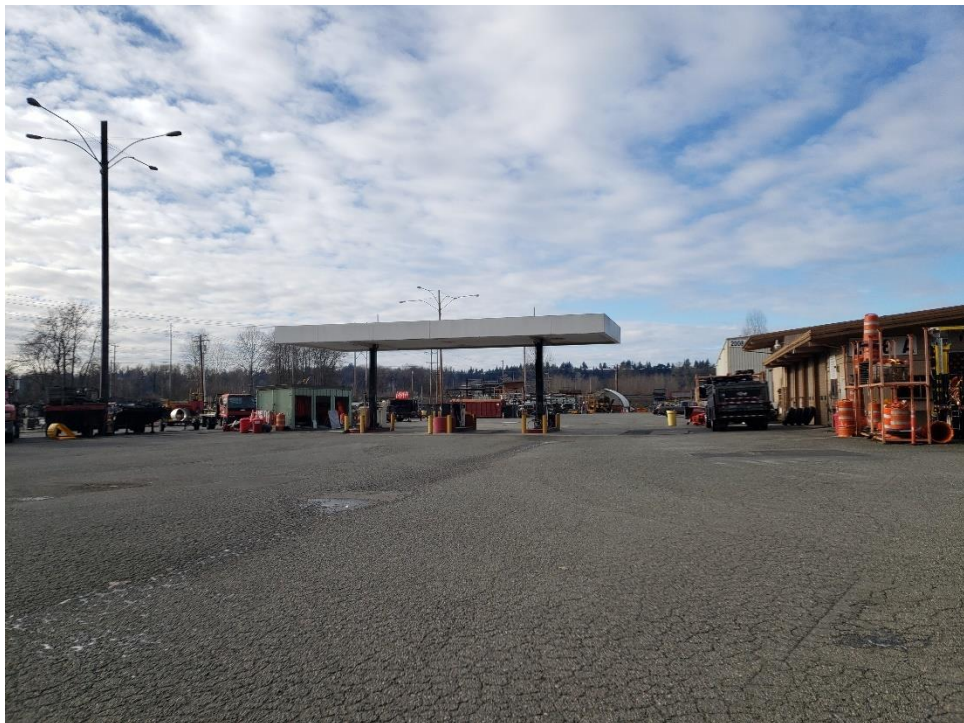
**Photo 26** Typical view of the west-adjointing parent parcel fueling (2008 E Valley Highway E), facing west from Parcel A.
